Inspection Report

Property Address:
1234 Anywhere Street
Anytown WI 65432

Date: 11/23/2011	Time: 01:30 PM	Report ID: 113211-8
Property: 1234 Anywhere Street Anytown WI 65432	Customer: John Doe	Real Estate Professional: Jane Doe Shoreast Realty

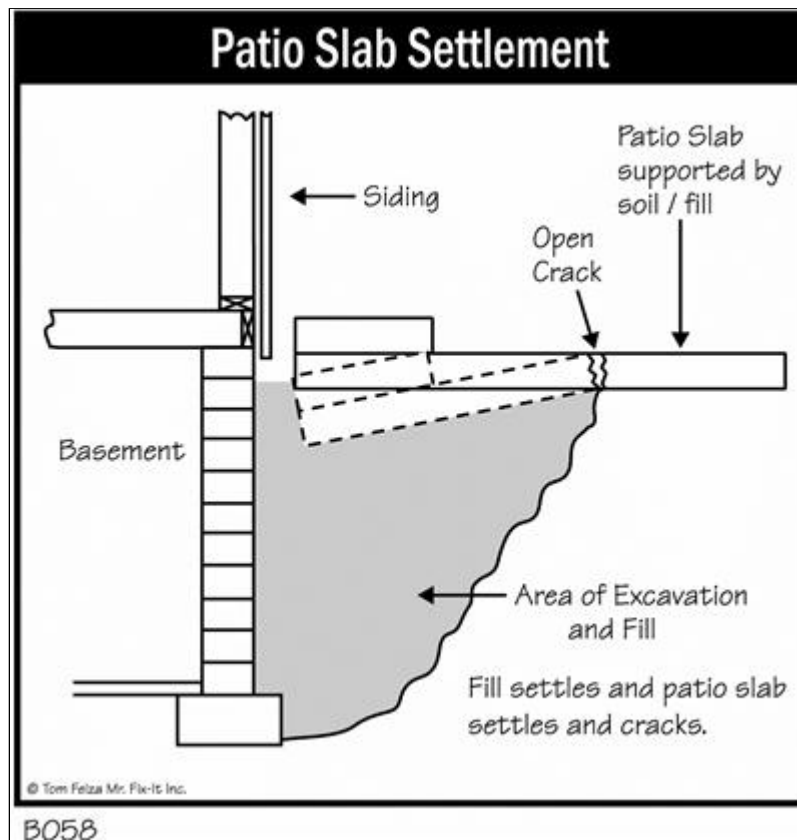
1.3 Picture 1

1.3 Patio settled and slopes drainage towards home. This can cause foundation or moisture problems in basement. Recommend a contractor to give buyer options and pricing of corrective action.

Mud jacking may be an option.

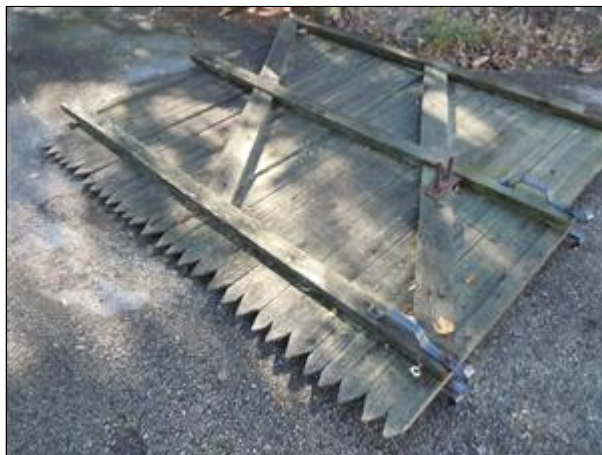
1.5 Picture 1

1.5 Repairs needed to fences and gates in various areas.

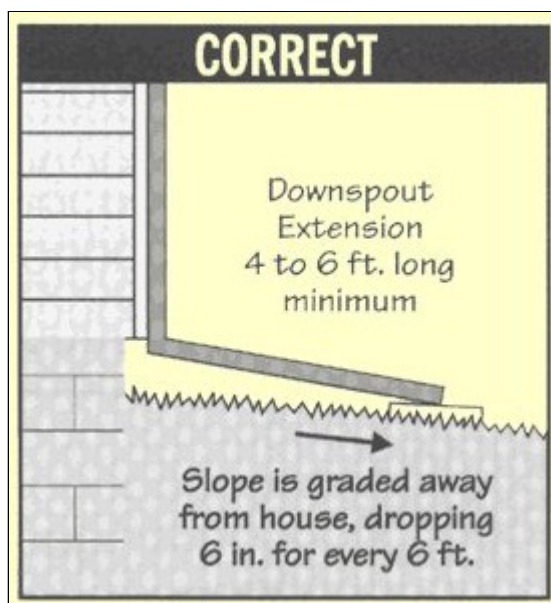
1.6 Picture 1

FYI: Grading, clean gutters, and downspout extensions are an important part of a home maintenance plan. If proper grade is not maintained, water can saturate the earth and create pressure against the foundation wall, and damage the wall.

Recommendation: The drainage grade away from the foundation should be not less than 6%. (One inch of decline per lineal foot away from the foundation for 6 feet if possible).

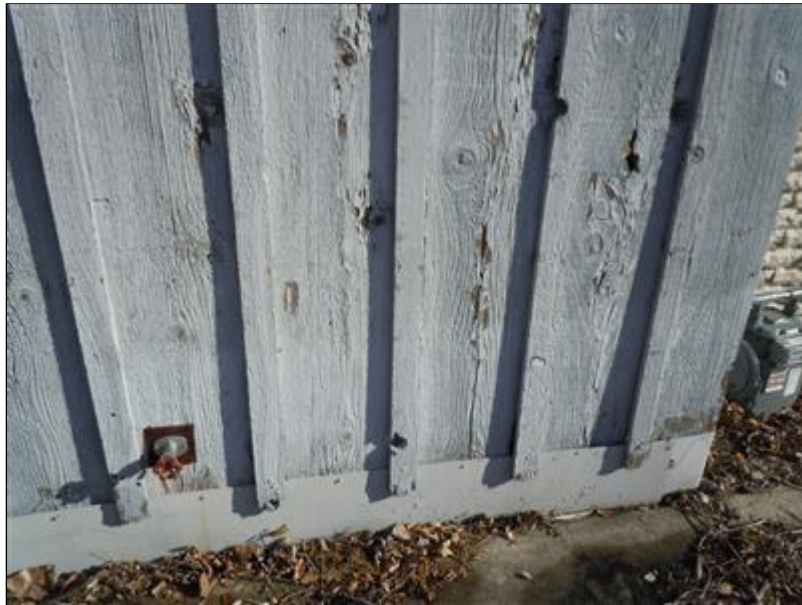
2.1 Picture 1

2.1 Some wood siding is aged and major deterioration is noted. Replacement is imminent. All wood exterior cladding has a life span and the end of it's life span is near. I recommend to consult a qualified contractor for an expert opinion and advise buyer of options.

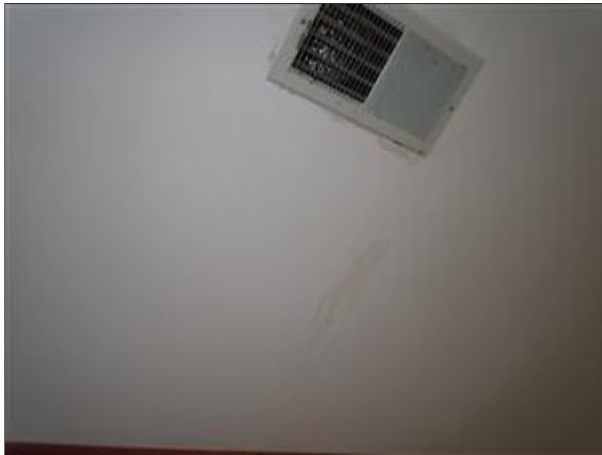
3.0 (1) The roof covering is old, and the life of covering has expired. The covering does need to be replaced. Areas of leakage noted today. Replacement is needed. Some of roof sheathing needs replacement also because of mold and water damage.

3.0 Picture 1 roof leak

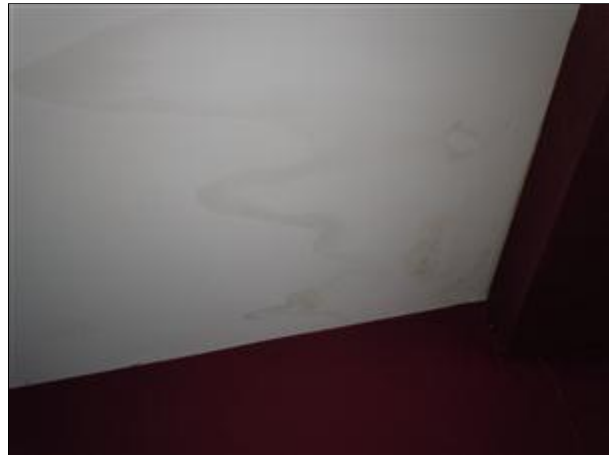
3.0 Picture 2 roof leak by chimney

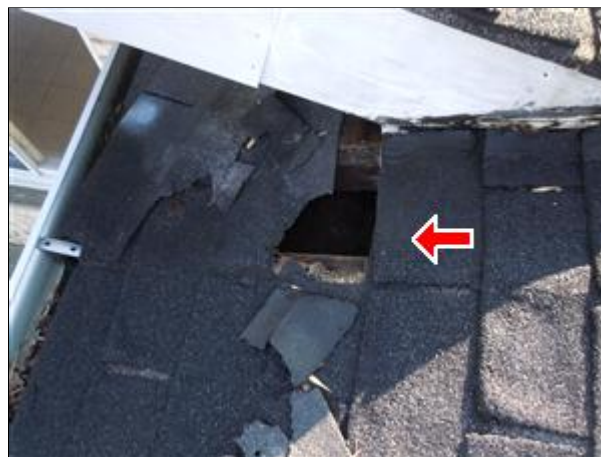
3.0 Picture 6

(2) Large hole discovered above garage service door.

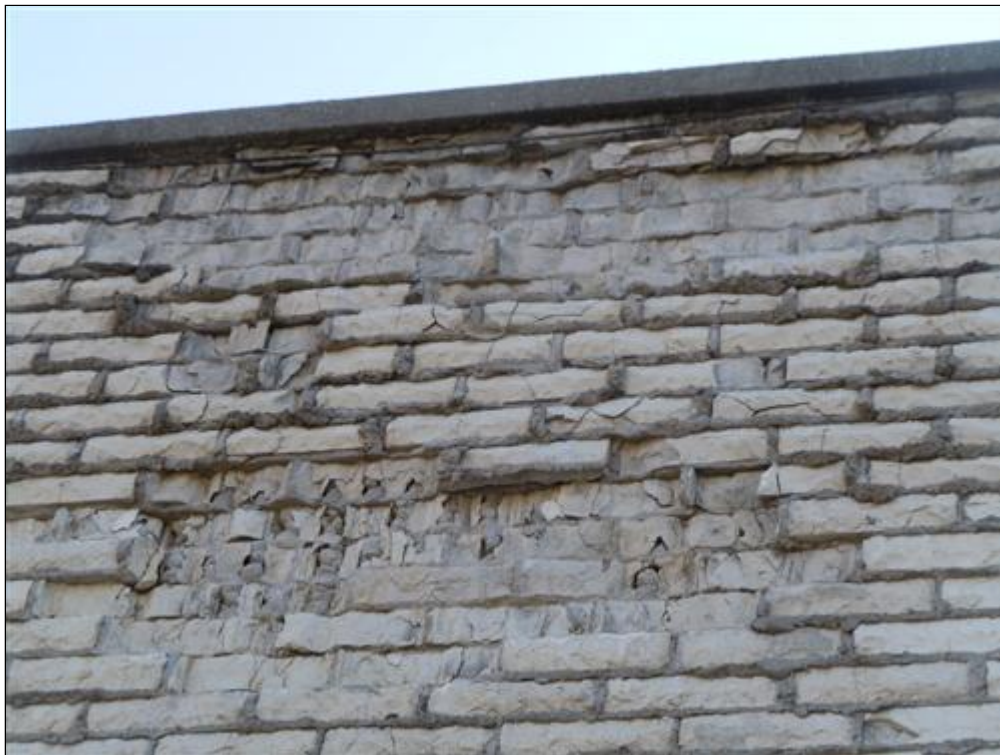
3.2 Picture 1

3.2 Moderate deterioration noted to chimney. Recommend a qualified chimney specialist to further evaluate and quote repairs.

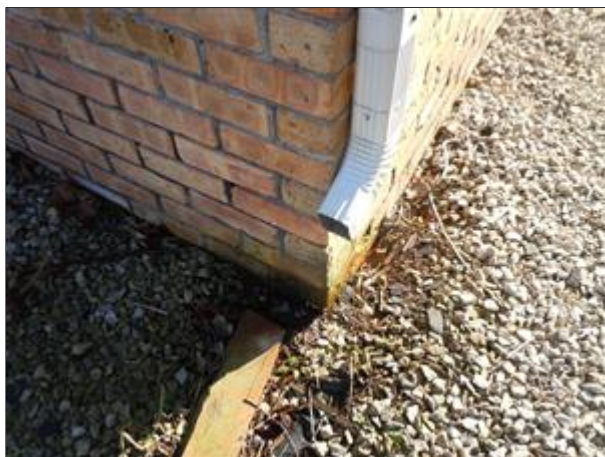
3.4 Picture 1

3.4 Debris in gutters. Gutters will not drain properly unless periodically cleaned. Proper management of rain water and snow melt is very important.

Extensions recommended to route water away from building.

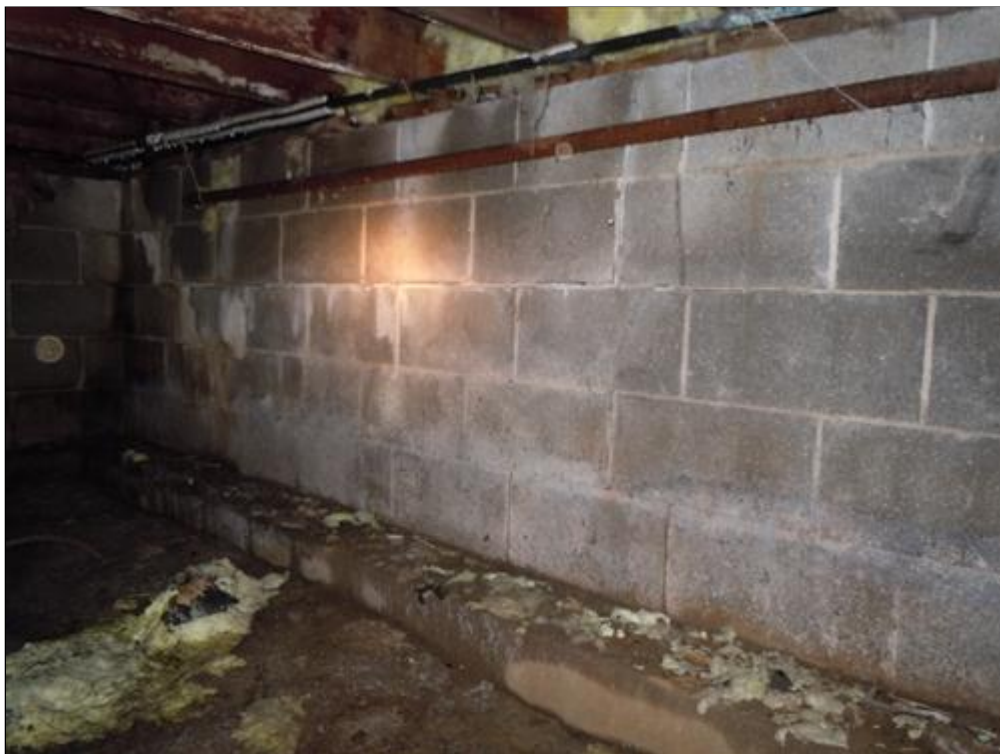
4.0 Picture 1

4.0 Noted foundation wall along patio out of plumb by an unacceptable amount possibly from improper grading, drainage, or expansive soil conditions. Horizontal and step cracks or walls tilting are often indicative of movement from the as-built condition. Recommend further evaluation by foundation consultant to determine course of remedial action.

Evidence of flooding noted. Much moisture in crawlspace. This has done structural damage already. Much fungal growth found also.

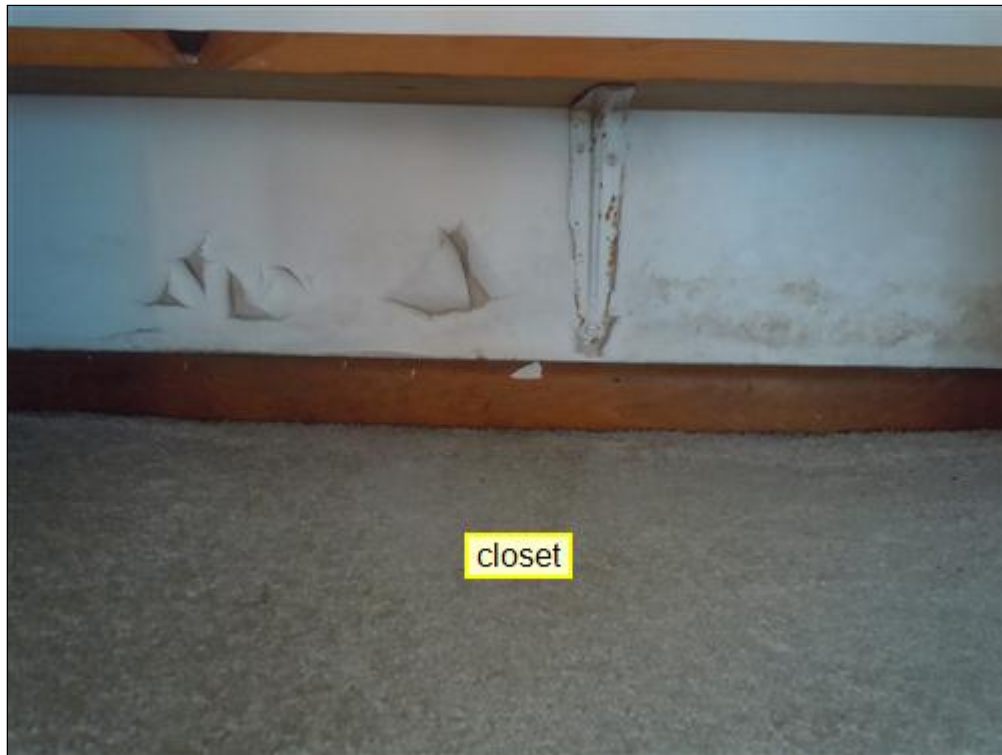
4.1 Picture 1

4.1 Noted wood evidence of destroying pests, mold and water damage in areas. Major repairs may be required. Recommend further evaluation and repairs as necessary.

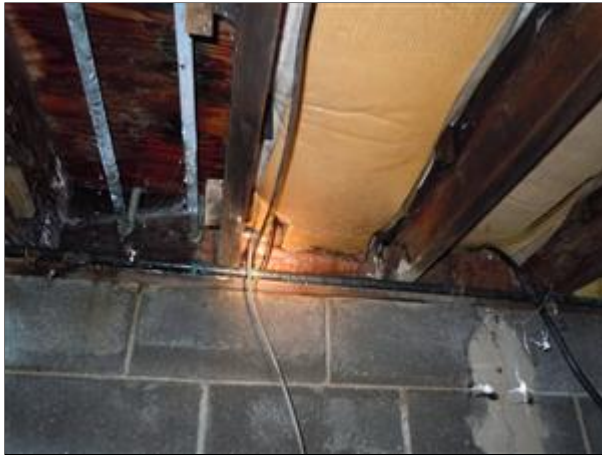
4.3 Picture 1

4.3 Signs of mold is present on floor system in crawlspace in several areas. We did not inspect, test or determine if this mold is or is not a health hazard. The underlying cause is moisture. I recommend you contact a mold inspector or expert for investigation or correction if needed.

Structural deficiencies from moisture damage noted in floor framing system that needs further evaluation by a structural engineer.

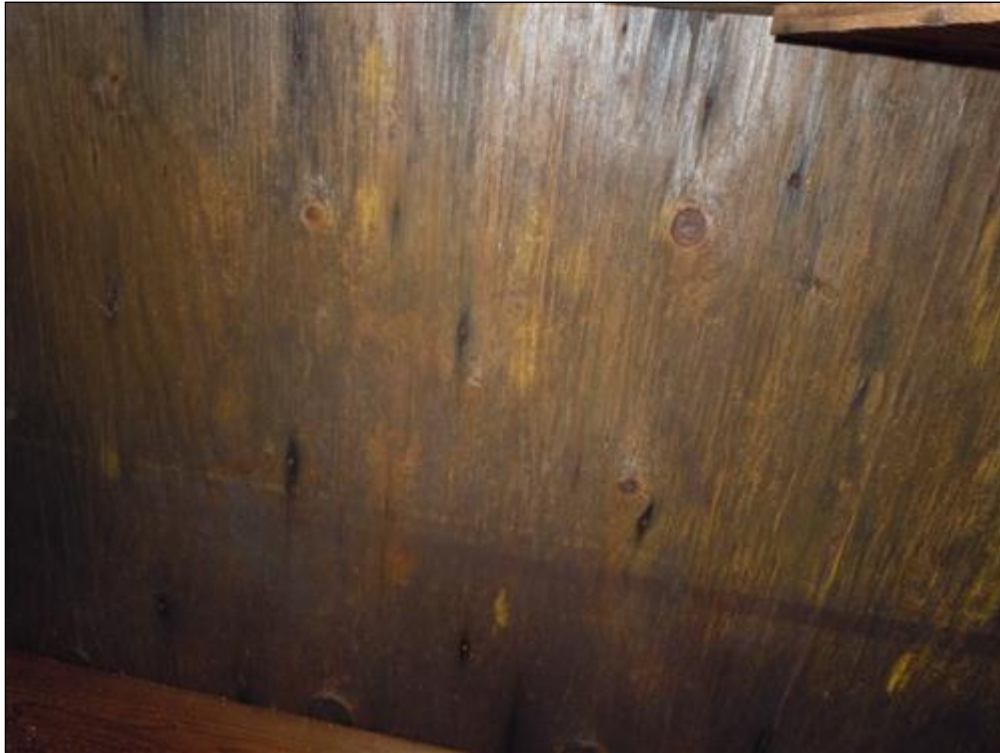
4.5 Picture 1

4.5 Roof sheathing is "blackened" in areas. Mold signs indicate that moisture inside attic may be contributing or causing the mold possibly from air leakage. The appearance may indicate mold, but this is not conclusive. No mold tests were performed by me or my company. If desired, I recommend you contact a mold inspection company for any test or considerations.

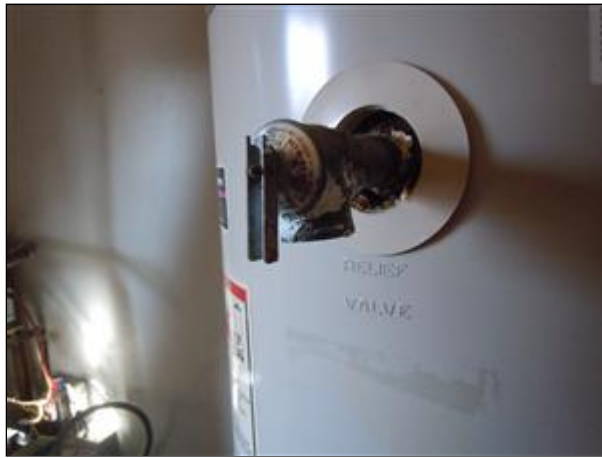
5.2 Picture 1

(2) T&P (Temperature and Pressure) valve on water heater needs a 3/4 threaded pipe to extend within 6 inches of floor for safety. (PVC is not approved for hot water use). Recommend repair by a qualified person.

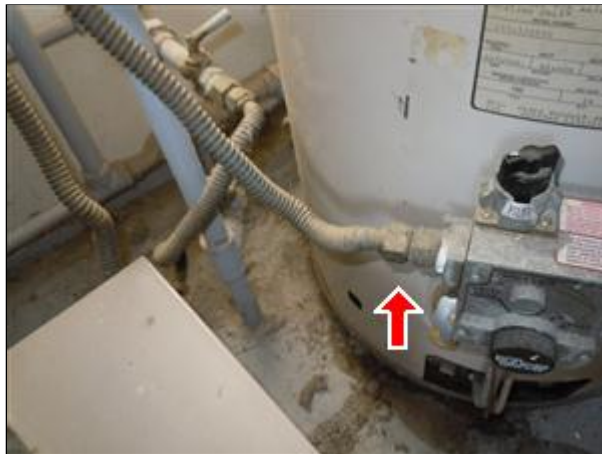
5.2 Picture 2

(3) Problem with water heater such as an improper gas line installed. Recommend a proper gas line installation by someone qualified.

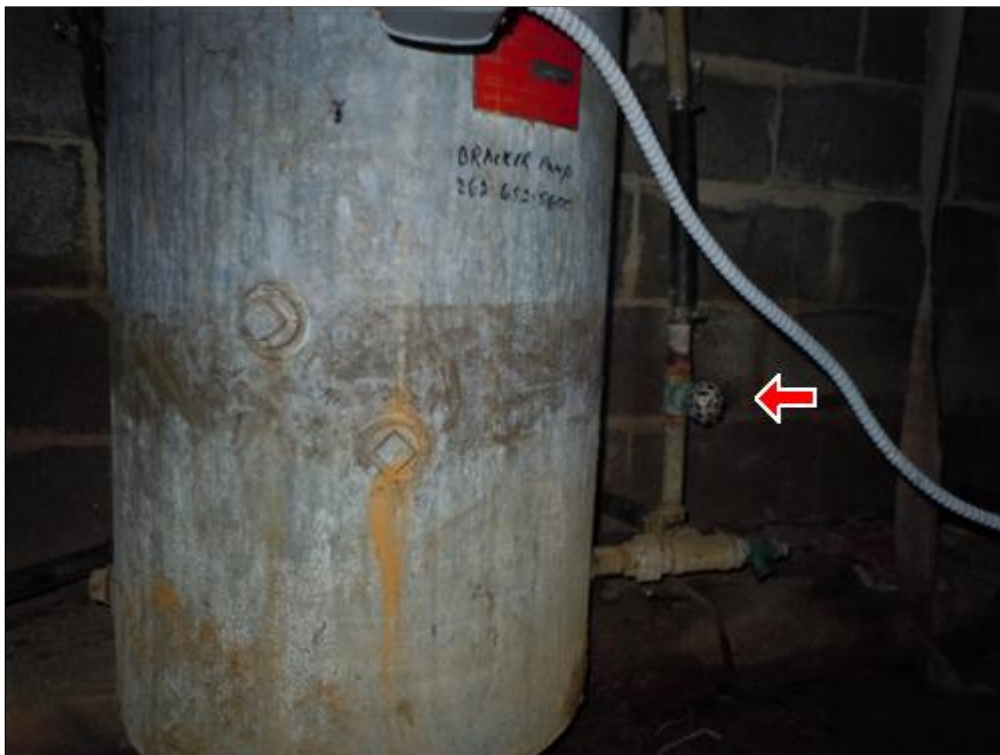
5.3 Picture 1

5.3 The main water shut off is located by the water pressure tank in crawl space. This is for your information only.

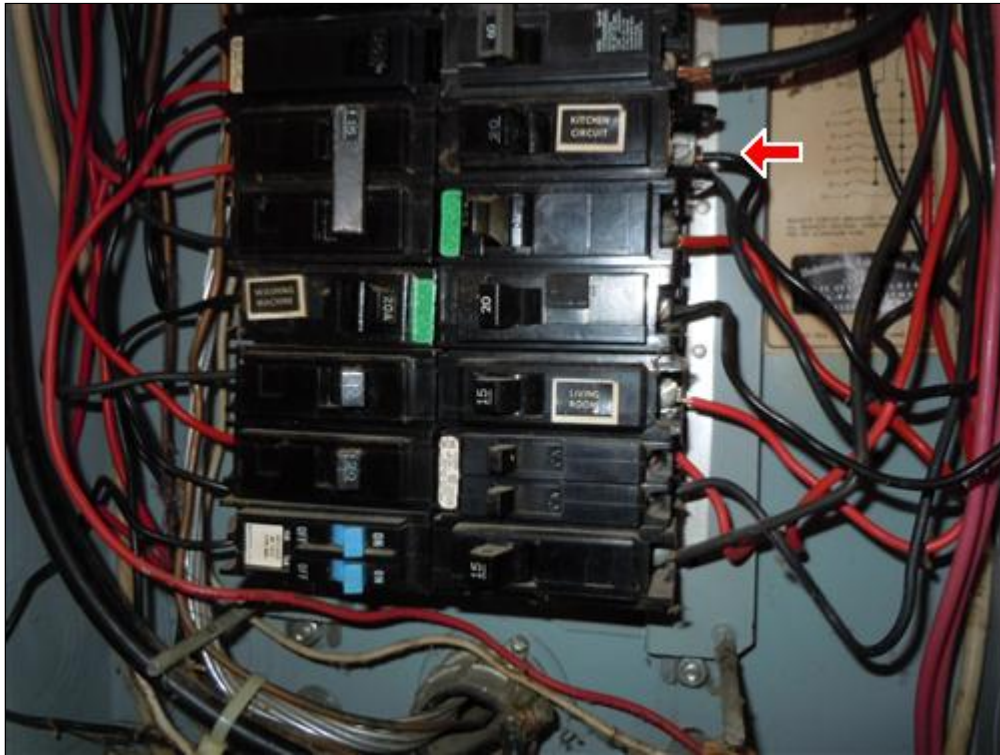
6.1 Picture 1

6.1 Some labels are present, but illegible or confusing. Recommend correcting for safety reasons.

Problem(s) discovered in panel such as doubled wiring at circuit(s), and any other problems that an electrician may discover while performing repairs need correcting. Recommend a licensed electrician inspect further and correct as needed.

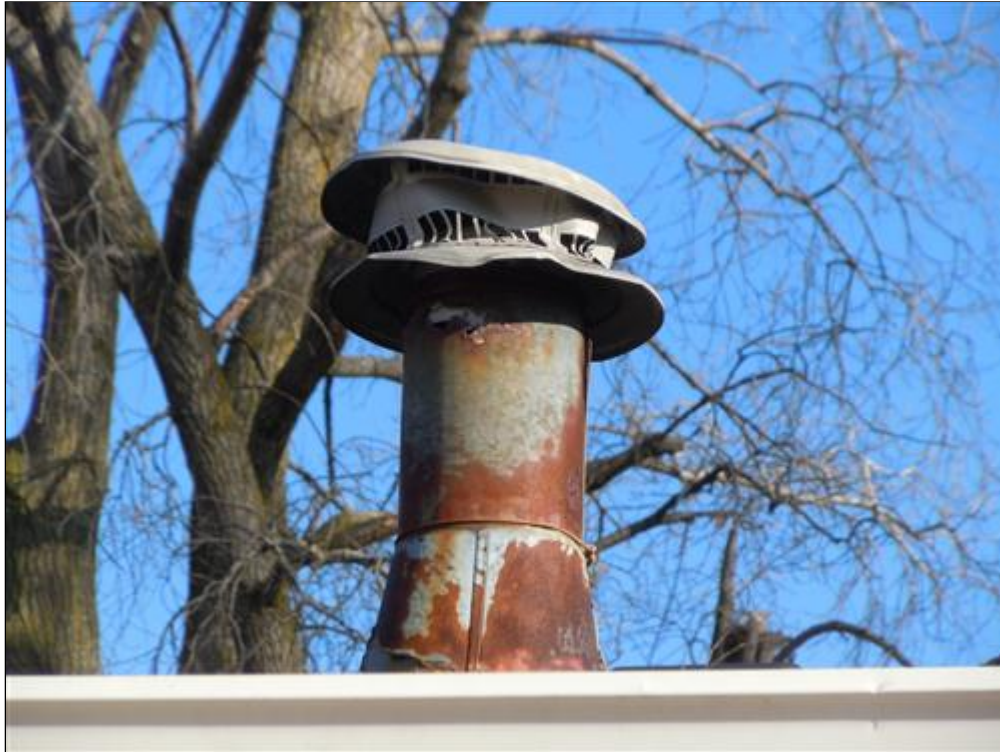
7.3 Picture 1

7.3 Cap and possibly vent pipe needs replacement for boiler.

Recommend a qualified licensed heat contractor inspect further and repair as needed.

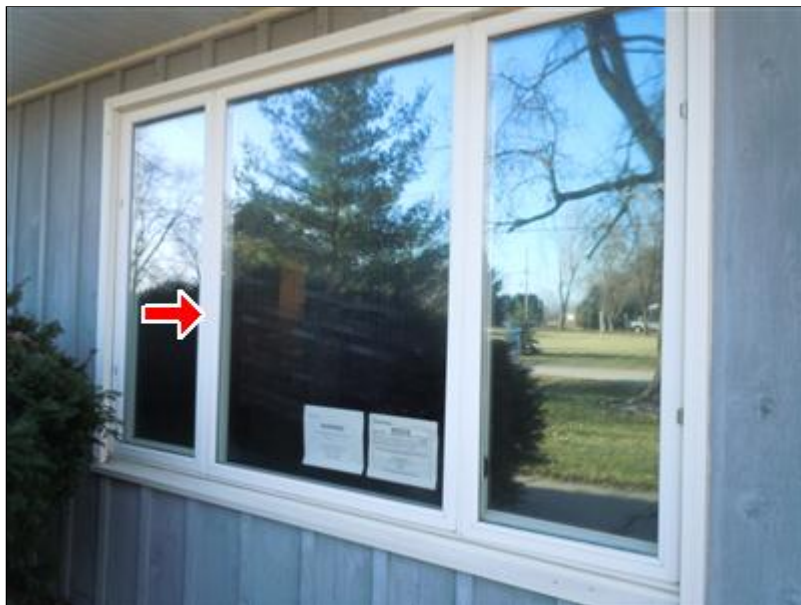
9.5 Picture 1

9.5 Dual pane window is fogged at front. May need replacement.

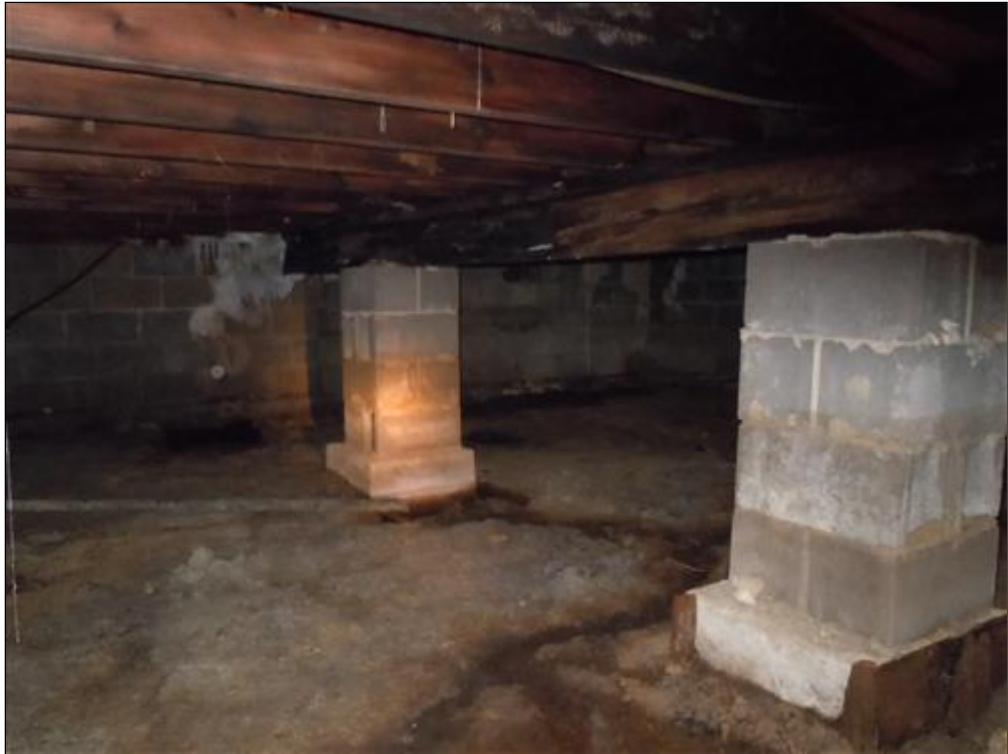
10.0 Picture 1

10.0 Vapor barrier (plastic) on crawlspace ground is missing. A vapor barrier provides added protection to floor system from moisture or dampness that can enter from ground. Recommend repair.

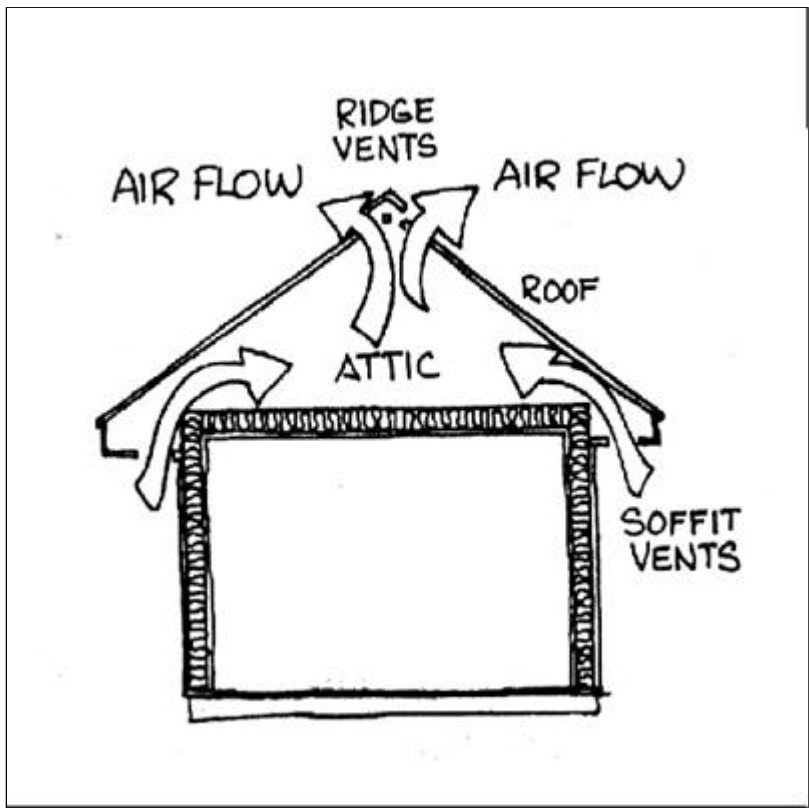
10.1 Picture 1

10.1 Poor ventilation noted at soffits. Recommend correction by someone qualified. Ventilation in attic is not adequate. A proper balance of ventilation should be calculated.

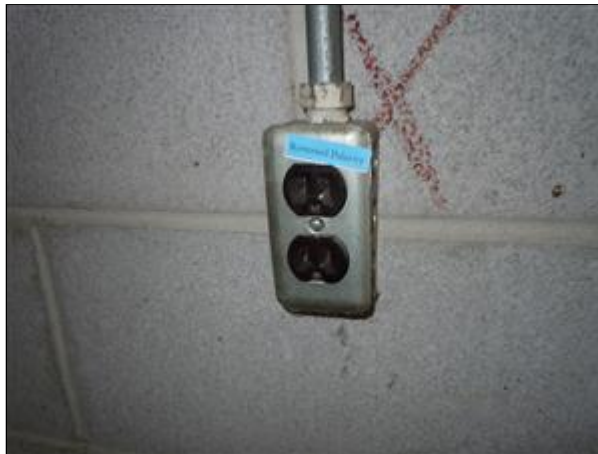
11.6.A Picture 1

11.6.A GFCI recommended for safety.

Reverse polarity as labeled. This is a safety hazard.

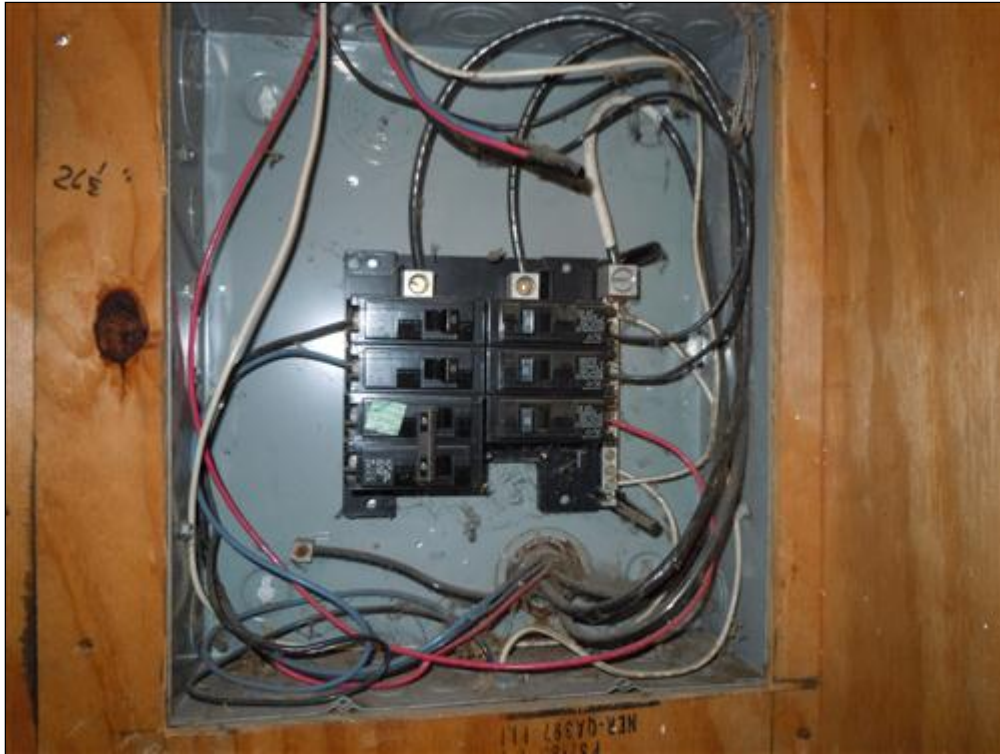
11.6.B Picture 1

11.6.B Neutral and ground is not isolated in sub panel. Also a disconnect is missing. Recommend correction by a licensed electrician.

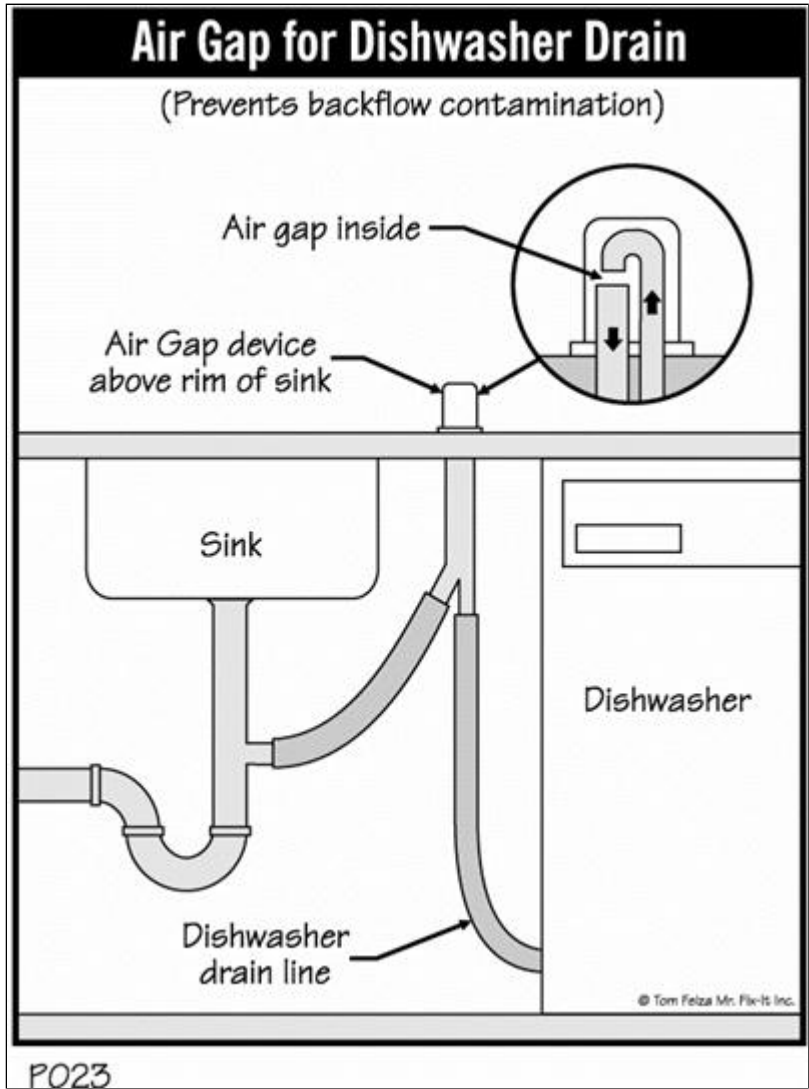
12.3 Picture 1

12.3 No air gap installed for dishwasher. Recommend installing one. Refer to manufacturers instructions. Air gaps are required by most codes for dishwashers and for water softeners. They are needed to prevent any possible cross-connection between your potable water system and your sewage system. Without an air gap, there is always a chance (however slim) of siphoning contaminants from your sewage system into your drinking water system.

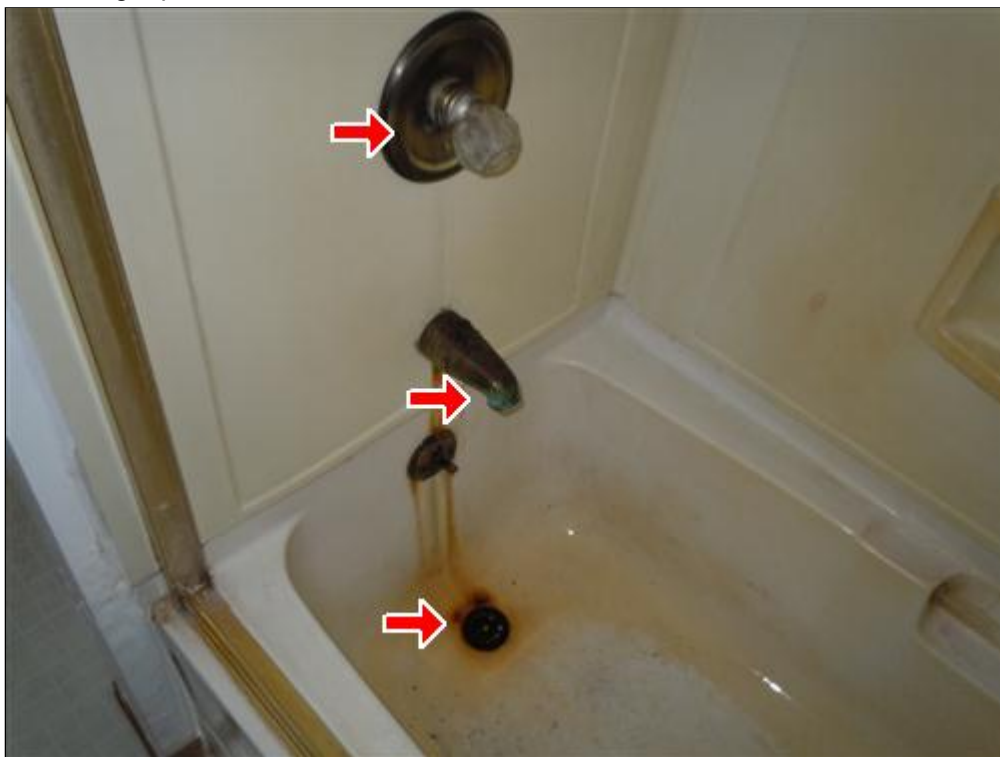
13.3 Picture 1

13.3 Leak noted at drain pipe under tub needing repairs.

Leak noted at faucet needing repairs.
