Inspection Report

Property Address:
1234 Anywhere Street
Anytown WI 65432

Date: 11/23/2011	Time: 01:30 PM	Report ID: 113211-8
Property: 1234 Anywhere Street Anytown WI 65432	Customer: John Doe	Real Estate Professional: Jane Doe Shoreast Realty

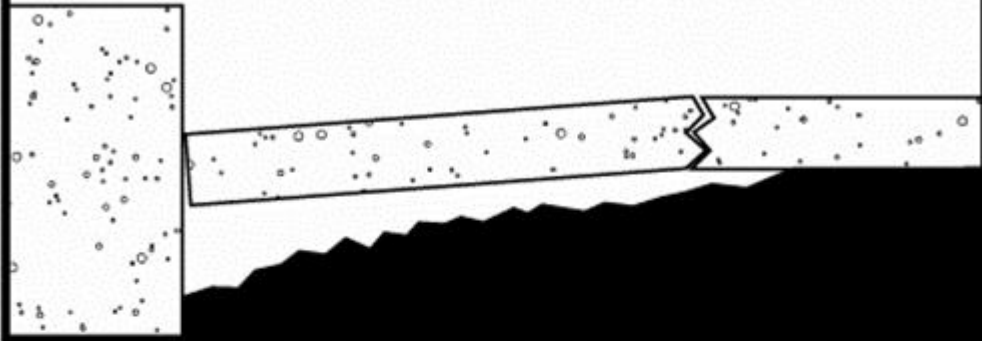
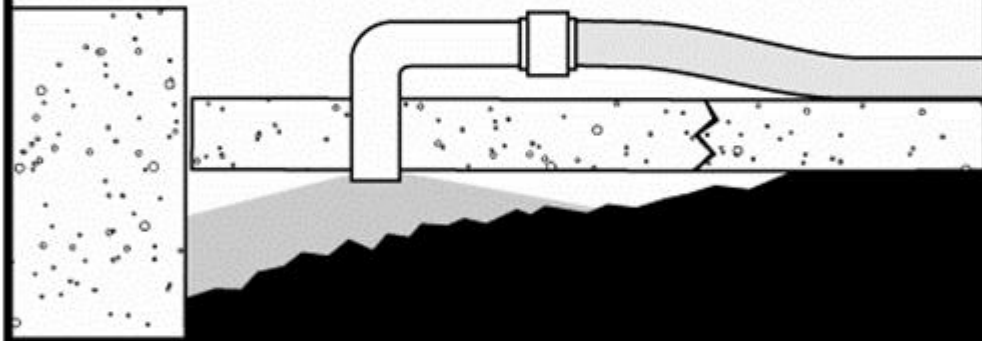
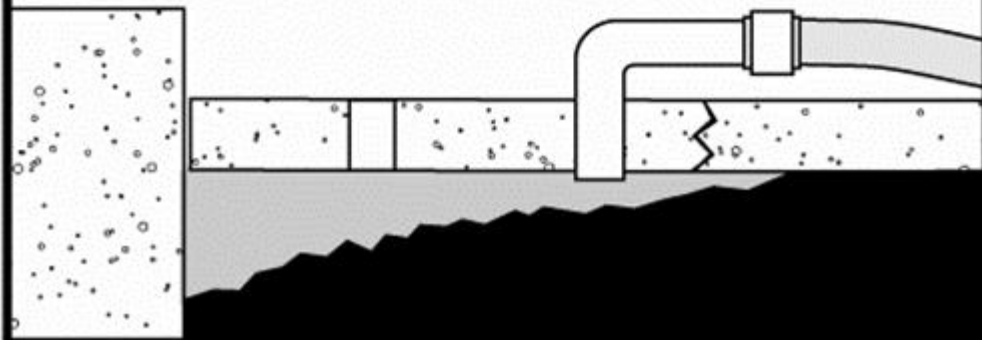
1.3 Patio settled and slopes drainage towards home. This can cause foundation or moisture problems in basement. Recommend a contractor to give buyer options and pricing of corrective action.

Mudjacking

1. Typical broken concrete slab as a result of settling:

2. Pressure lifts the slab above a cone of "mud" forced through a drilled hole:

3. Additional holes are drilled to fill voids as needed to support the slab:

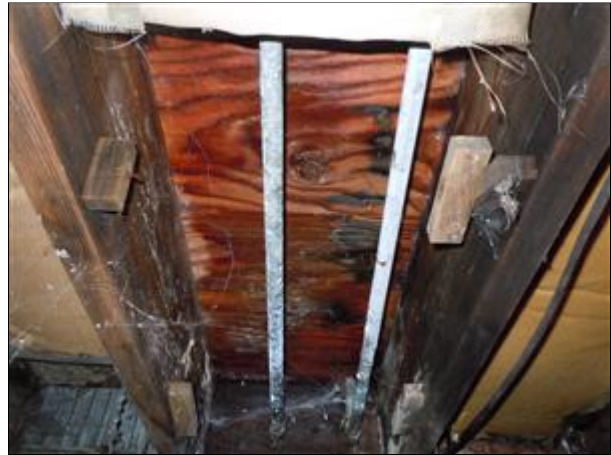
4.3 Picture 2

4.3 Signs of mold is present on floor system in crawlspace in several areas. We did not inspect, test or determine if this mold is or is not a health hazard. The underlying cause is moisture. I recommend you contact a mold inspector or expert for investigation or correction if needed.

Structural deficiencies from moisture damage noted in floor framing system that needs further evaluation by a structural engineer.

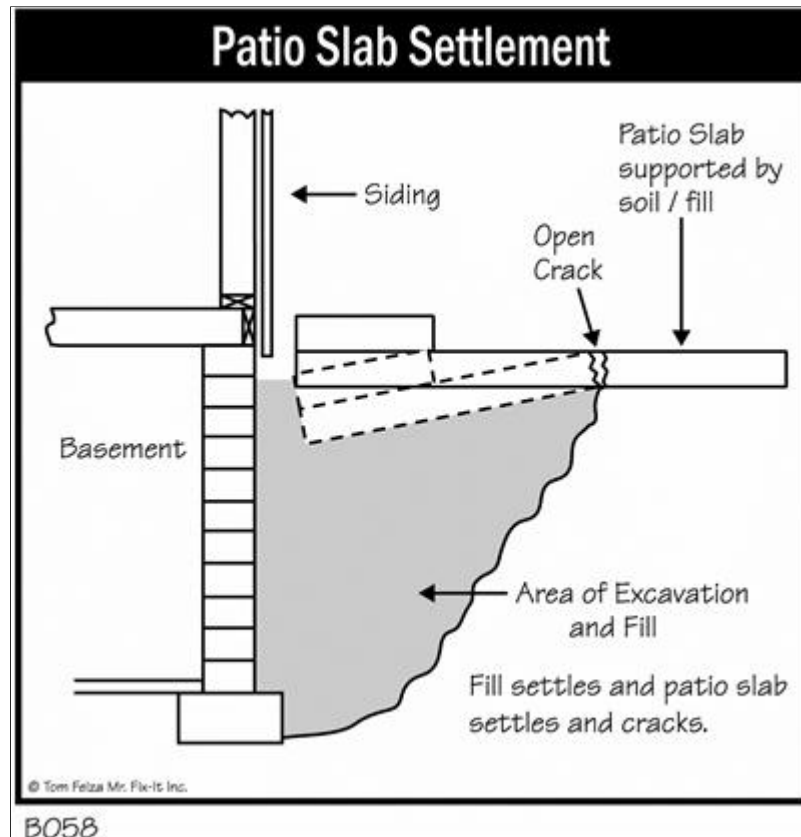
1.3 Picture 1

Patio settled and slopes drainage towards home. This can cause foundation or moisture problems in basement. Recommend a contractor to give buyer options and pricing of corrective action.

Mud jacking may be an option.

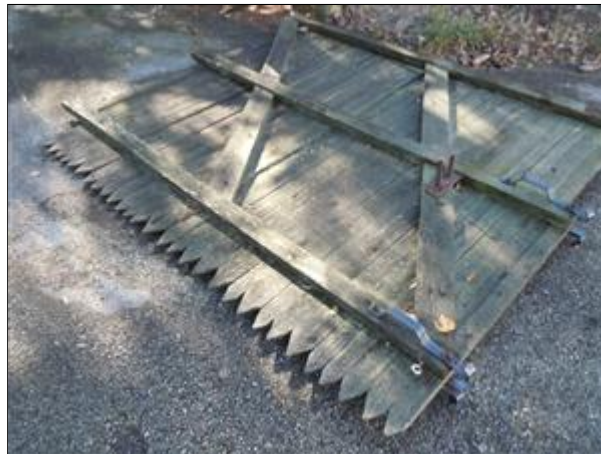
1.5 Picture 1

Repairs needed to fences and gates in various areas.

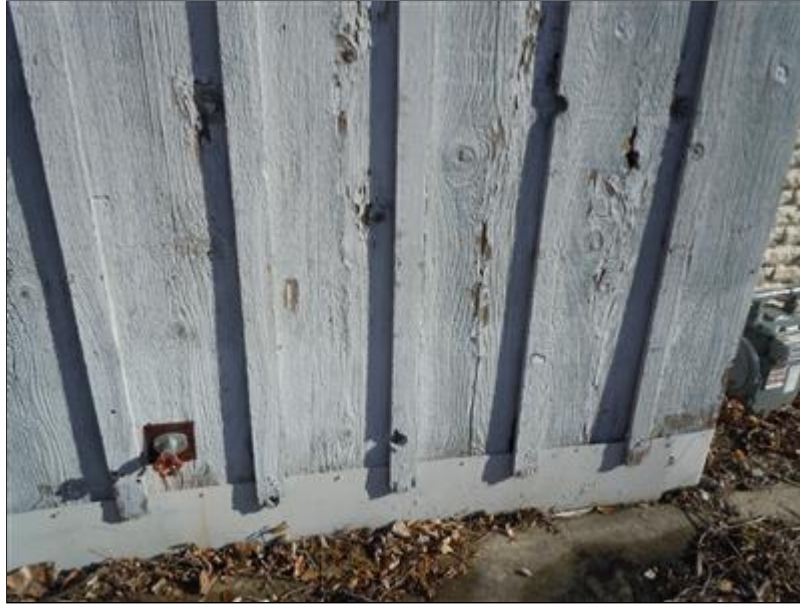
2.1 Picture 1

Some wood siding is aged and major deterioration is noted. Replacement is imminent. All wood exterior cladding has a life span and the end of it's life span is near. I recommend to consult a qualified contractor for an expert opinion and advise buyer of options.

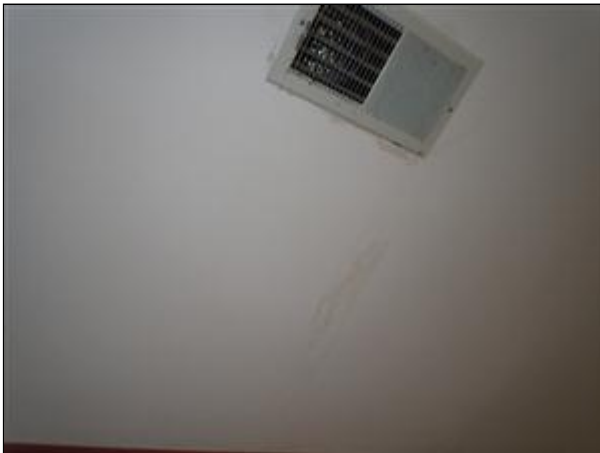
(1) The roof covering is old, and the life of covering has expired. The covering does need to be replaced. Areas of leakage noted today. Replacement is needed. Some of roof sheathing needs replacement also because of mold and water damage.

3.0 Picture 1 roof leak

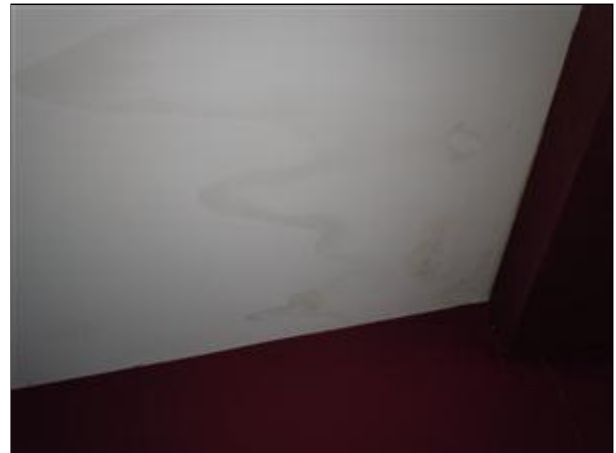
3.0 Picture 2 roof leak by chimney

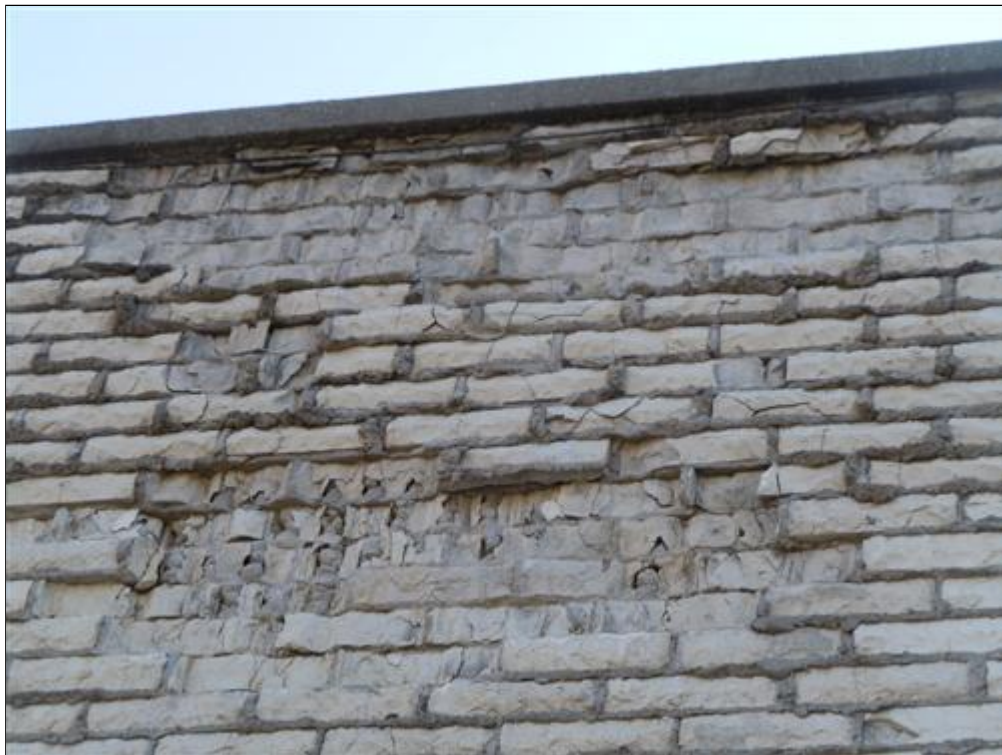
3.2 Picture 1

Moderate deterioration noted to chimney. Recommend a qualified chimney specialist to further evaluate and quote repairs.

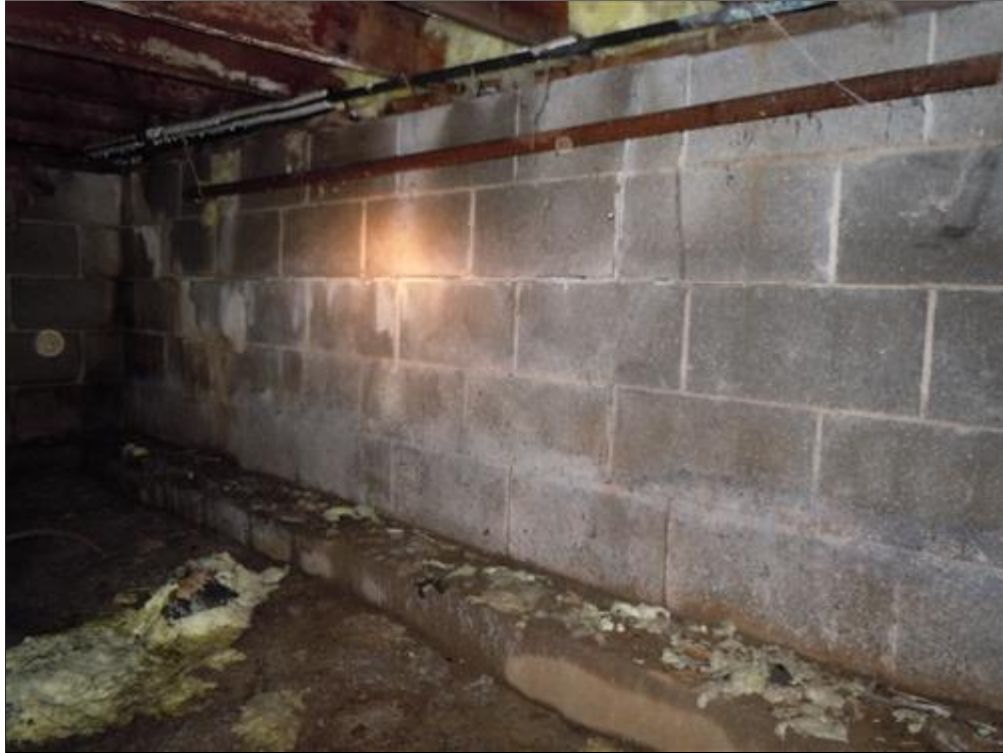
4.0 Picture 1

4.0 Noted foundation wall along patio out of plumb by an unacceptable amount possibly from improper grading, drainage, or expansive soil conditions. Horizontal and step cracks or walls tilting are often indicative of movement from the as-built condition. Recommend further evaluation by foundation consultant to determine course of remedial action.

Evidence of flooding noted. Much moisture in crawlspace. This has done structural damage already. Much fungal growth found also.

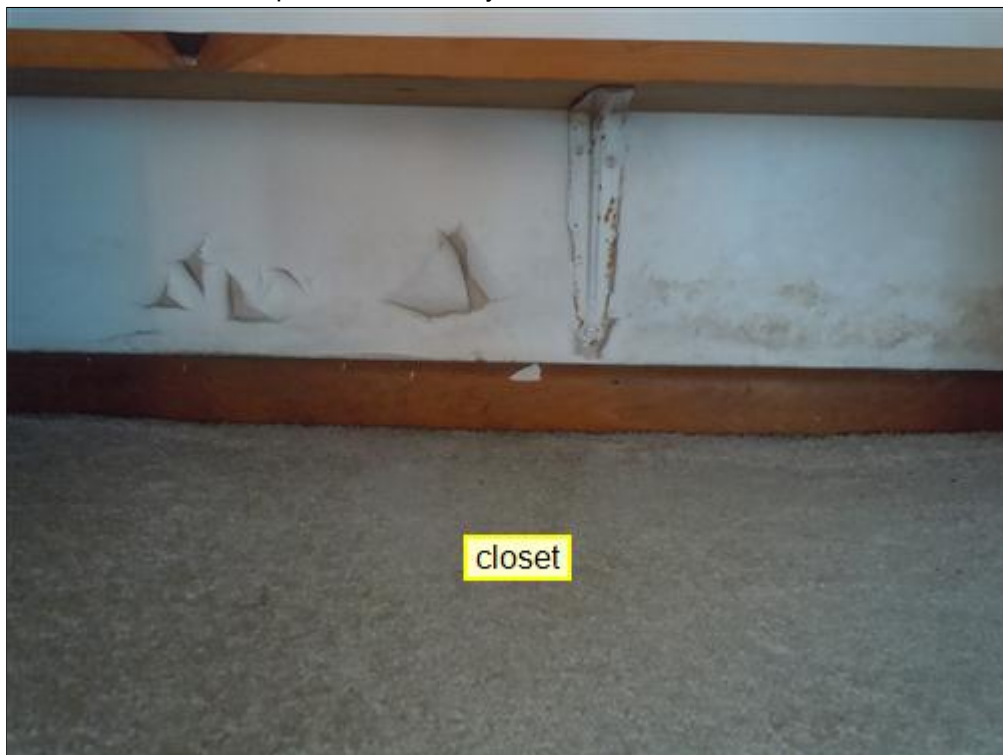
4.1 Picture 1

Noted wood evidence of destroying pests, mold and water damage in areas. Major repairs may be required. Recommend further evaluation and repairs as necessary.

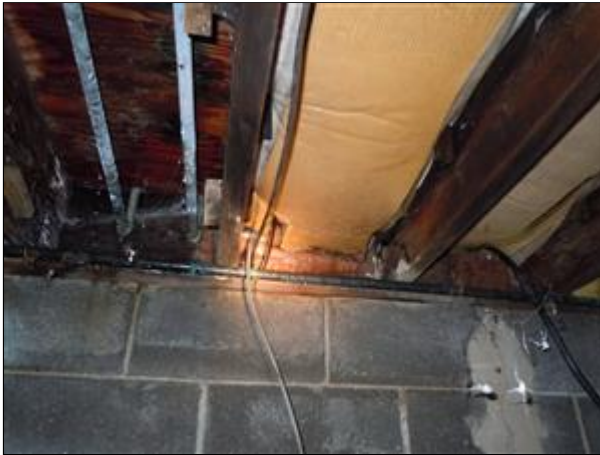
4.3 Picture 1

Structural deficiencies from moisture damage noted in floor framing system that needs further evaluation by a structural engineer.

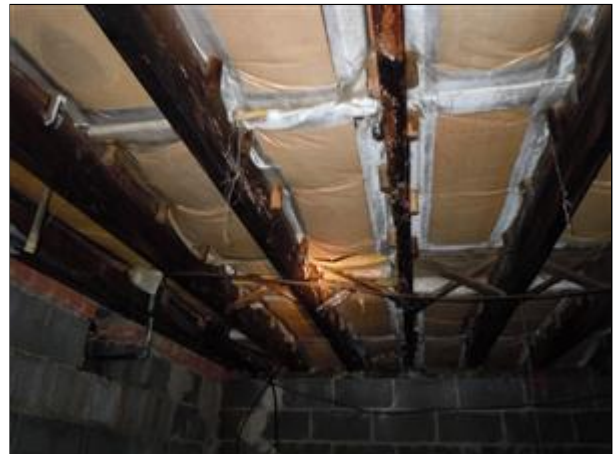
4.3 Picture 4

Signs of mold is present on floor system in crawlspace in several areas. We did not inspect, test or determine if this mold is or is not a health hazard. The underlying cause is moisture. I recommend you contact a mold inspector or expert for investigation or correction if needed.

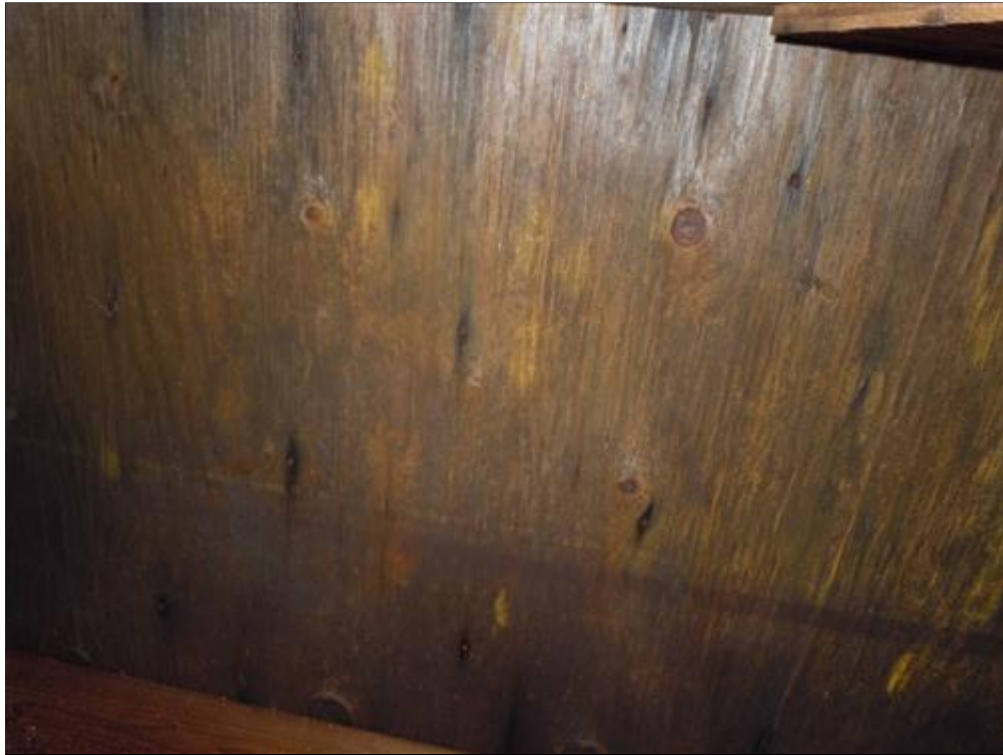
4.5 Picture 1

Roof sheathing is "blackened" in areas. Mold signs indicate that moisture inside attic may be contributing or causing the mold possibly from air leakage. The appearance may indicate mold, but this is not conclusive. No mold tests were performed by me or my company. If desired, I recommend you contact a mold inspection company for any test or considerations.

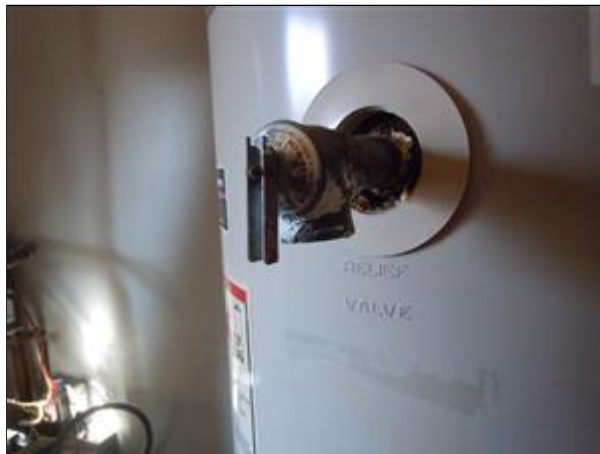
5.2 Picture 1

(2) T&P (Temperature and Pressure) valve on water heater needs a 3/4 threaded pipe to extend within 6 inches of floor for safety. (PVC is not approved for hot water use). Recommend repair by a qualified person.

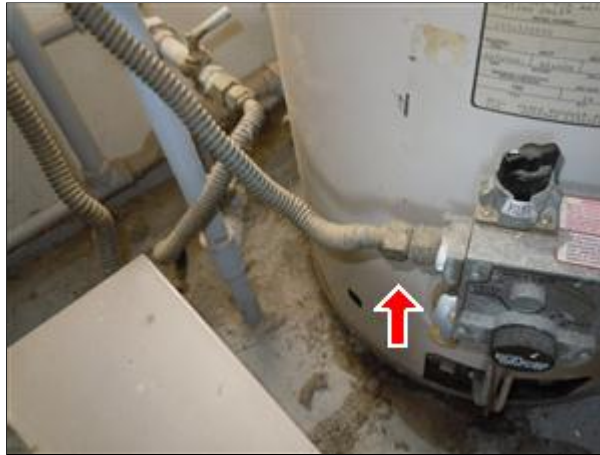
5.2 Picture 2

(3) Problem with water heater such as an improper gas line installed. Recommend a proper gas line installation by someone qualified.

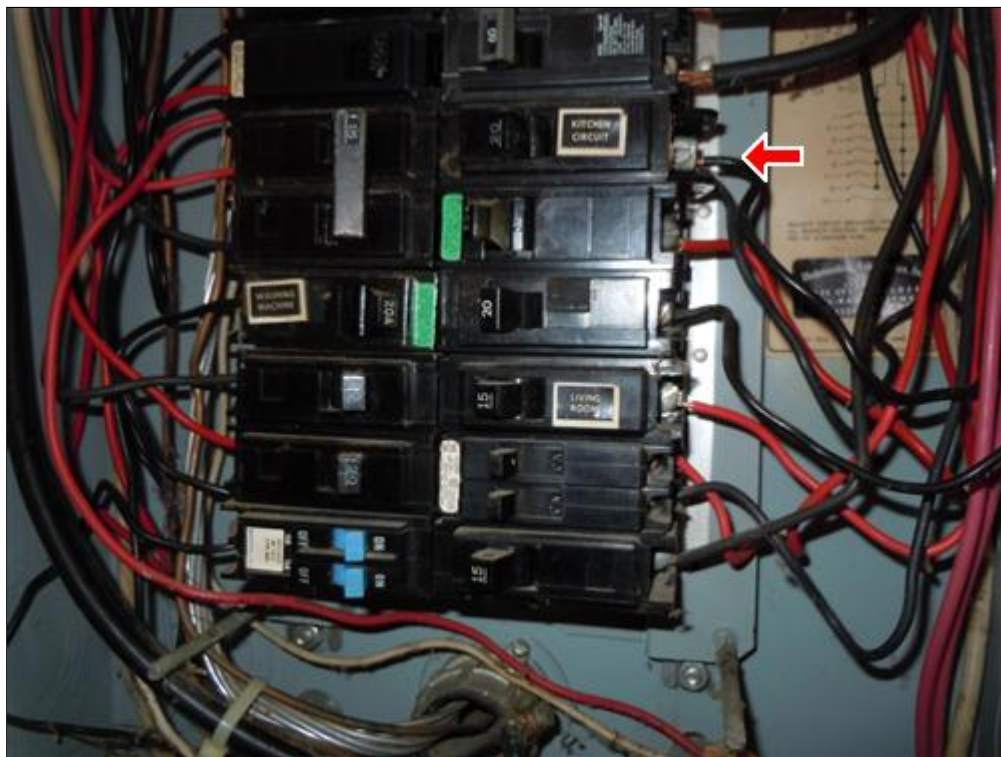
6.1 Picture 1

Some labels are present, but illegible or confusing. Recommend correcting for safety reasons.

Problem(s) discovered in panel such as doubled wiring at circuit(s), and any other problems that an electrician may discover while performing repairs need correcting. Recommend a licensed electrician inspect further and correct as needed.

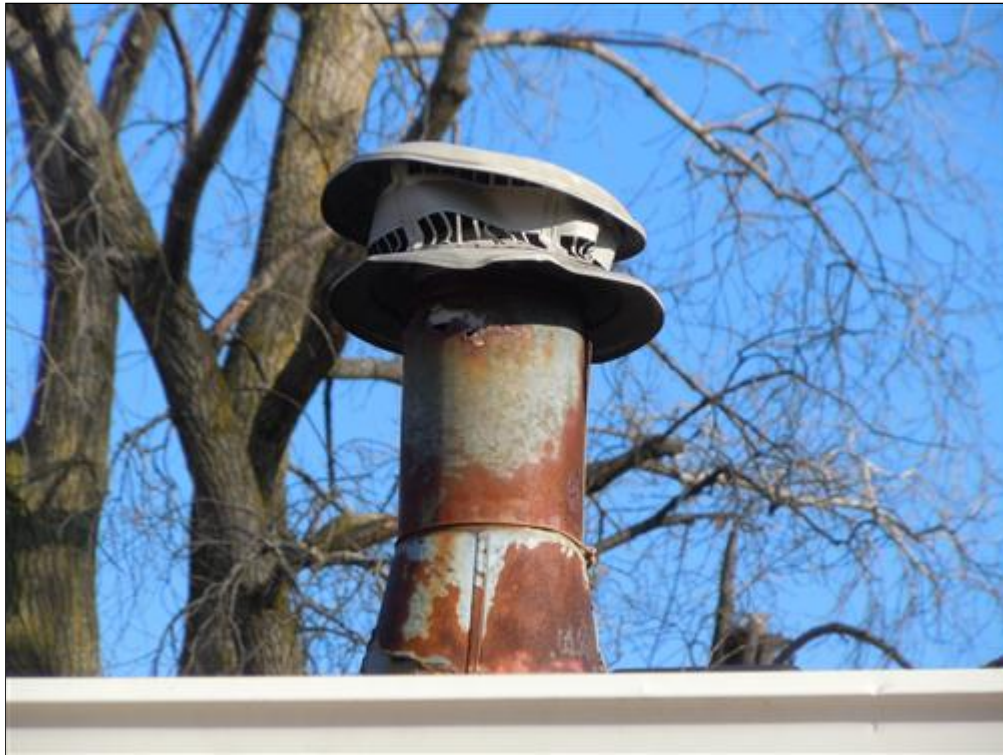
7.3 Picture 1

Cap and possibly vent pipe needs replacement for boiler.

Recommend a qualified licensed heat contractor inspect further and repair as needed.

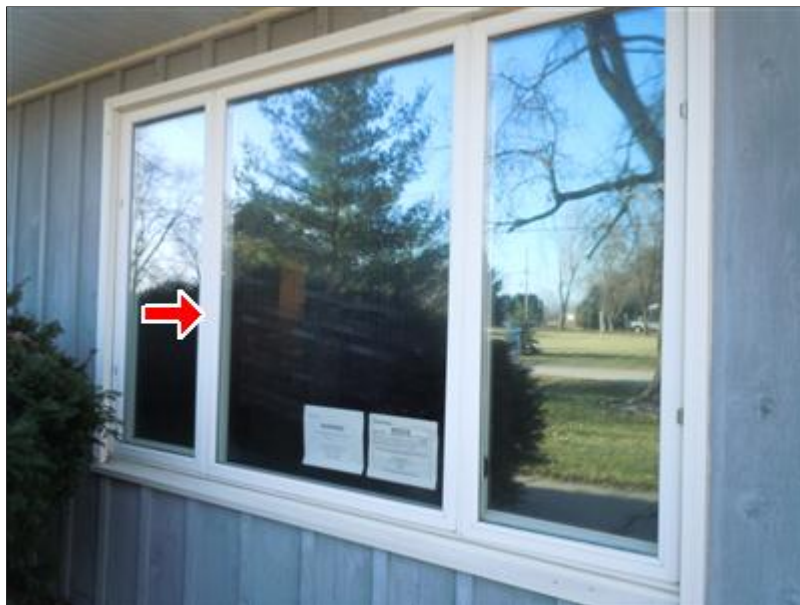
9.5 Picture 1

Dual pane window is fogged at front. May need replacement.

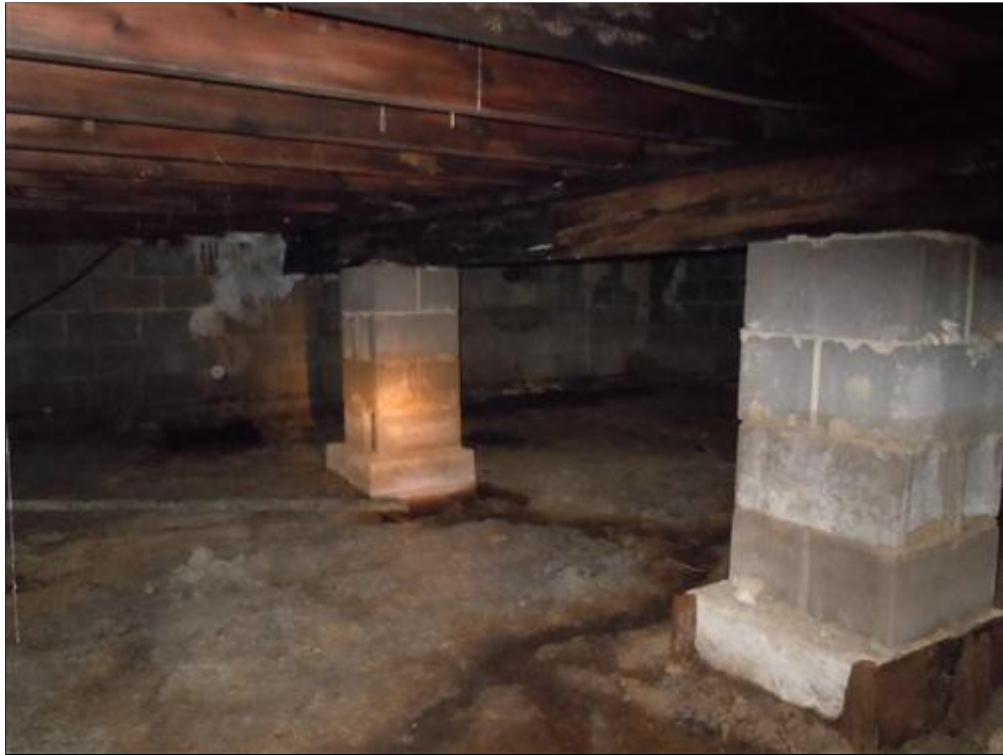
10.0 Picture 1

Vapor barrier (plastic) on crawlspace ground is missing. A vapor barrier provides added protection to floor system from moisture or dampness that can enter from ground. Recommend repair.

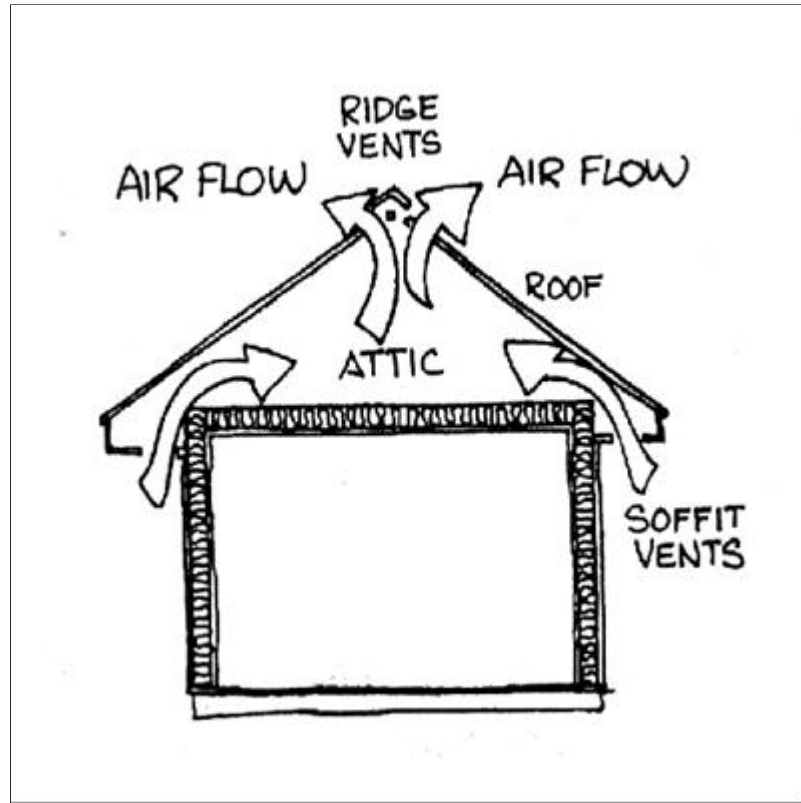
10.1 Picture 1

Poor ventilation noted at soffits. Recommend correction by someone qualified. Ventilation in attic is not adequate. A proper balance of ventilation should be calculated.

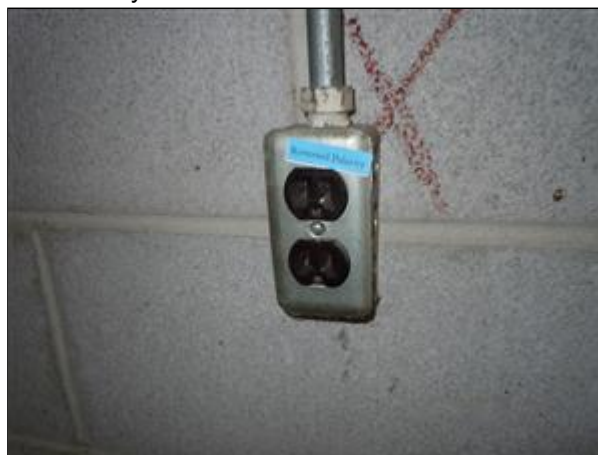
11.6.A Picture 1

GFCI recommended for safety.

Reverse polarity as labeled. This is a safety hazard.

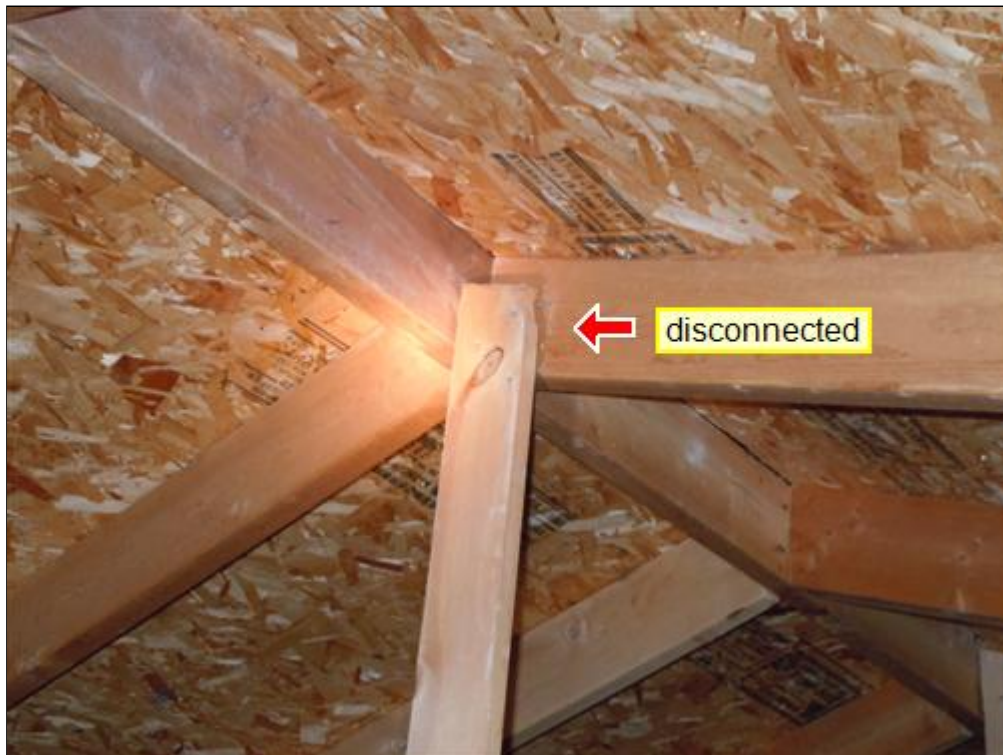
11.1.B Picture 1

Appears that the ceiling is over spanned. Ceiling is sagged. Structural repairs needed.

Recommend a contractor to evaluate and advise buyer of the extent of repairs.

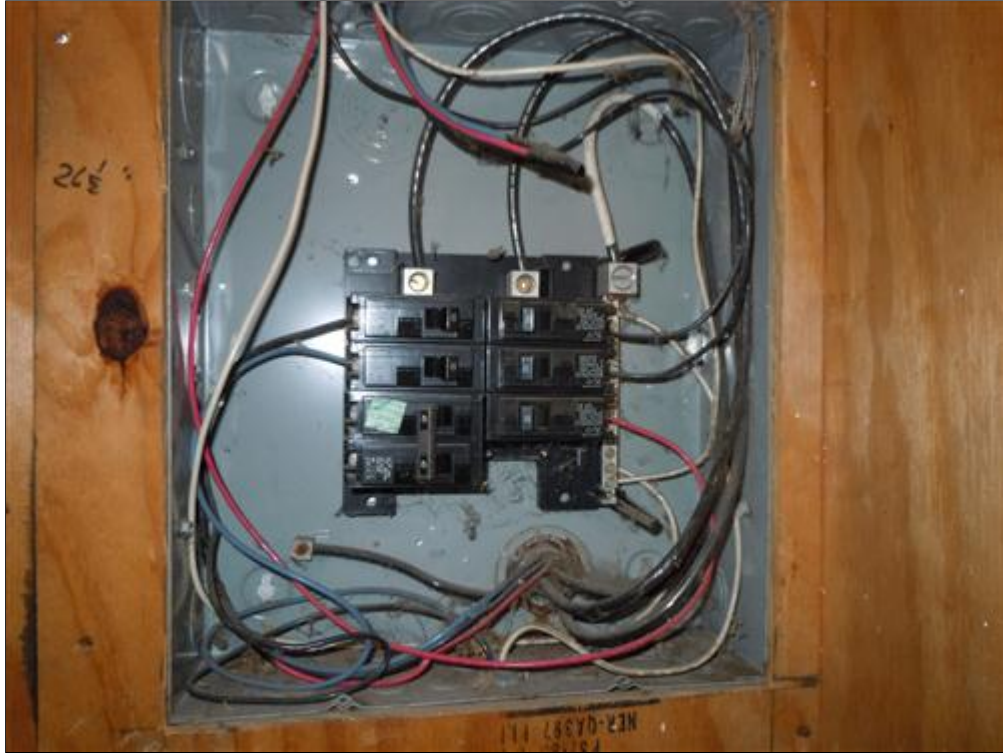
11.6.B Picture 1

Neutral and ground is not isolated in sub panel. Also a disconnect is missing. Recommend correction by a licensed electrician.

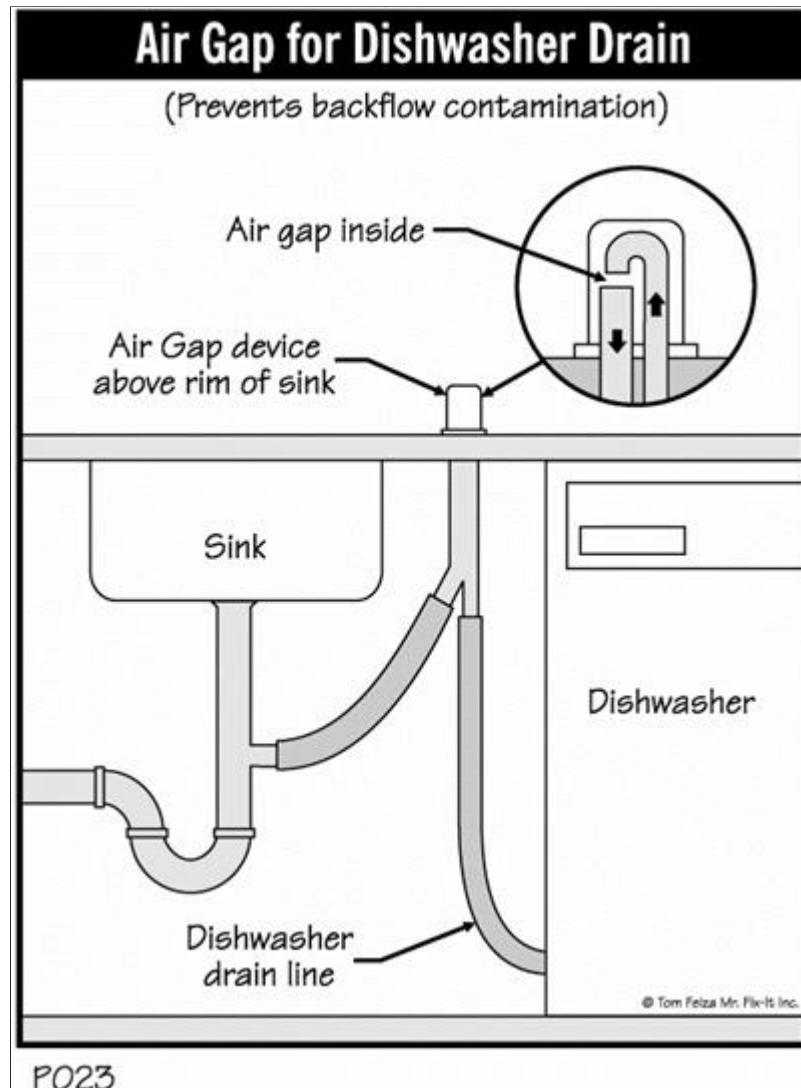
12.3 Picture 1

No air gap installed for dishwasher. Recommend installing one. Refer to manufacturers instructions. Air gaps are required by most codes for dishwashers and for water softeners. They are needed to prevent any possible cross-connection between your potable water system and your sewage system. Without an air gap, there is always a chance (however slim) of siphoning contaminants from your sewage system into your drinking water system.

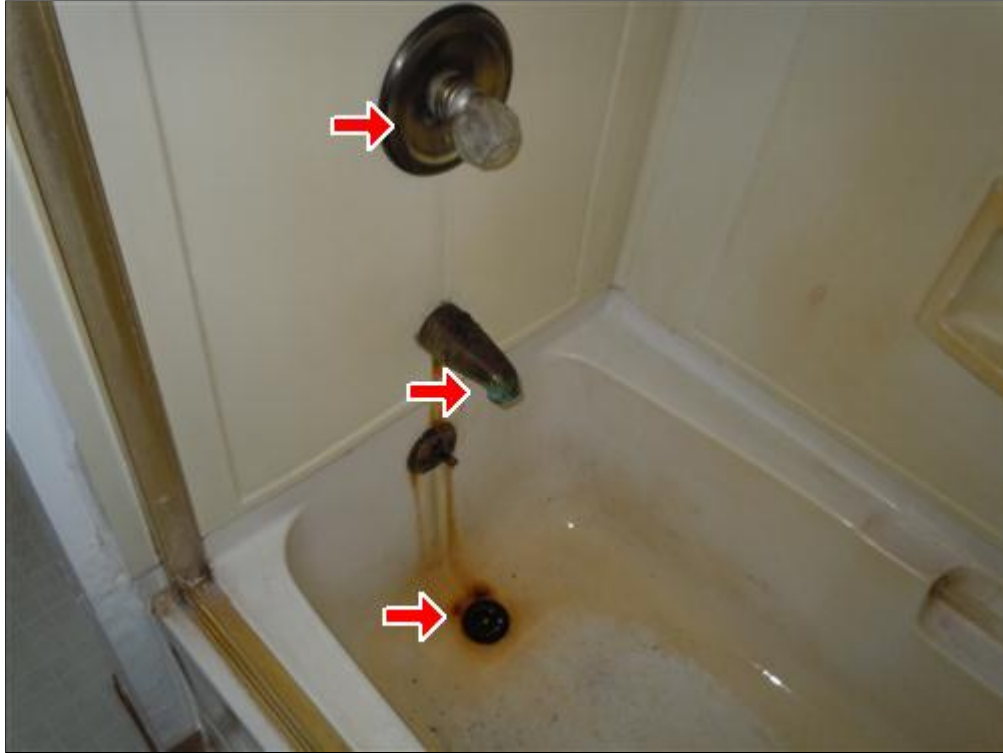
13.3 Picture 1

Leak noted at drain pipe under tub needing repairs.

Leak noted at faucet needing repairs.
